TECHNICAL REPORT REMR-CO-3

**CASE HISTORIES OF CORPS BREAKWATER
AND JETTY STRUCTURES**

**Report 2
SOUTH ATLANTIC DIVISION**

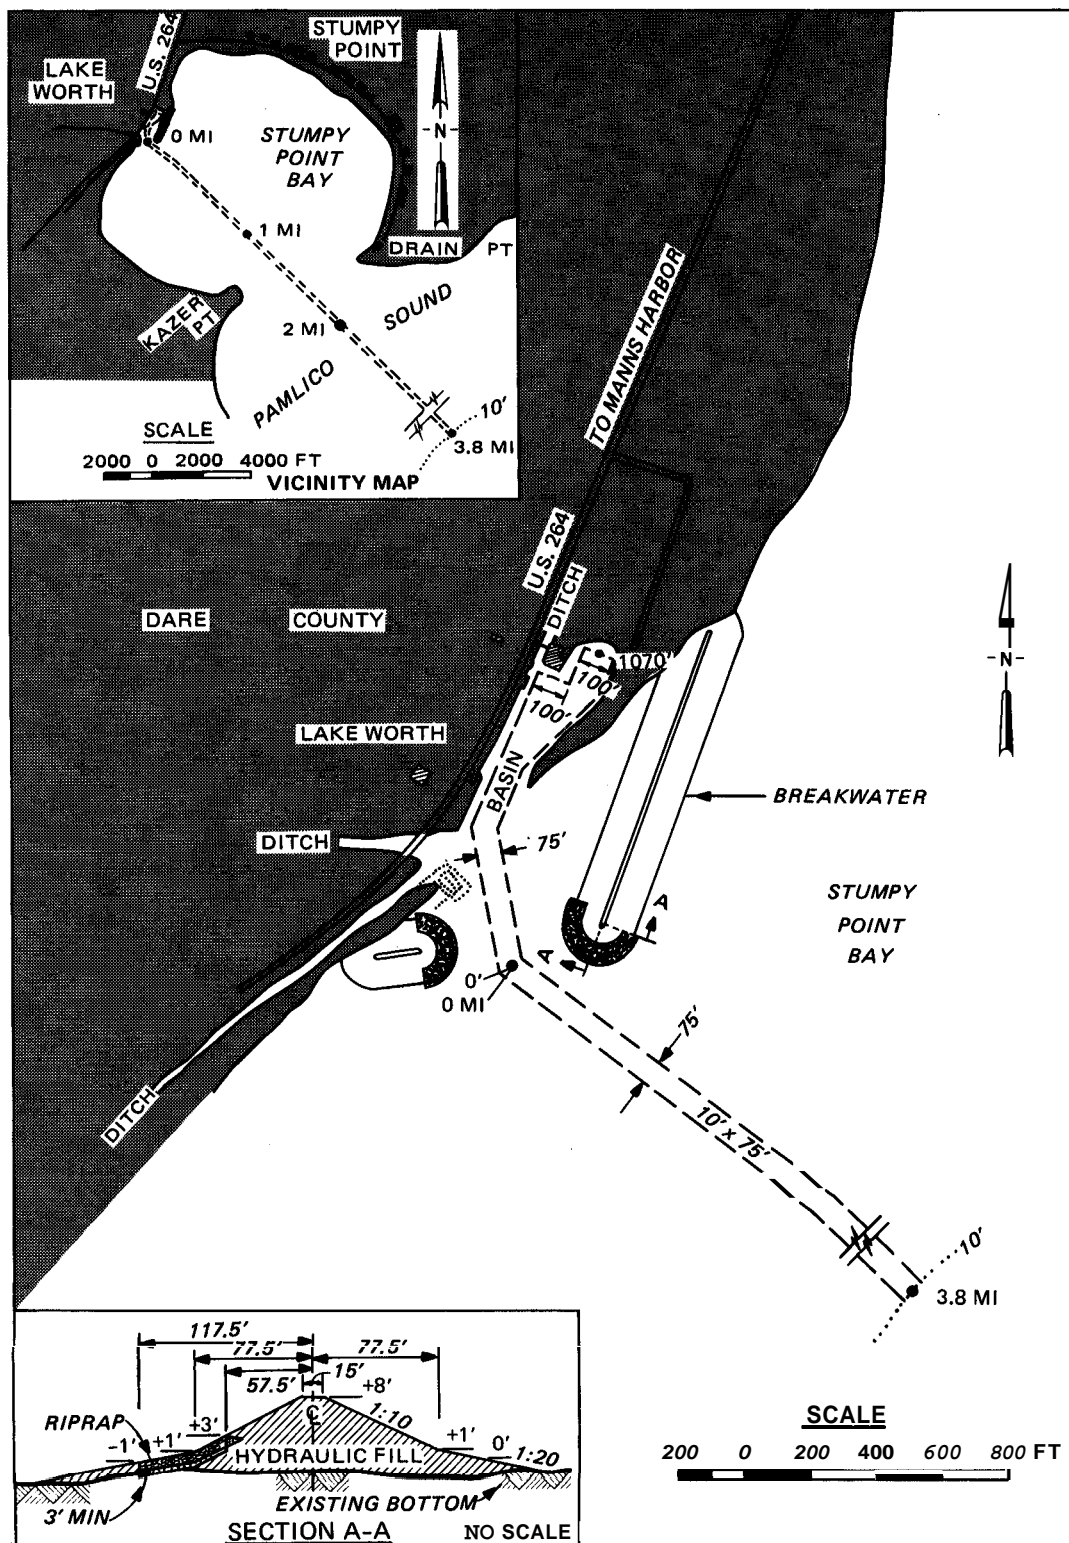
Figure 4. Stumpy Point Bay, North Carolina

1974	A reconnaissance survey was made to determine the severity of erosion to the breakwaters. It was found that the riprap protected sections were functioning satisfactorily but that the fill material adjacent to the riprap sections had substantially eroded. Maximum vertical scarps of 7, 3, and 3 ft, respectively, were noted on the bay and harbor sides of the north breakwater and bay side of the south breakwater. The erosion on the north breakwater was on directly opposite sides of the breakwater with only 30 ft of original material separating the narrowest point. It was felt that "the southeasterly wind with its associated fetch is very erosive to the breakwaters on both sides of the dredged channel."
1985	Neither repairs nor maintenance has been carried out since the breakwaters were originally constructed.

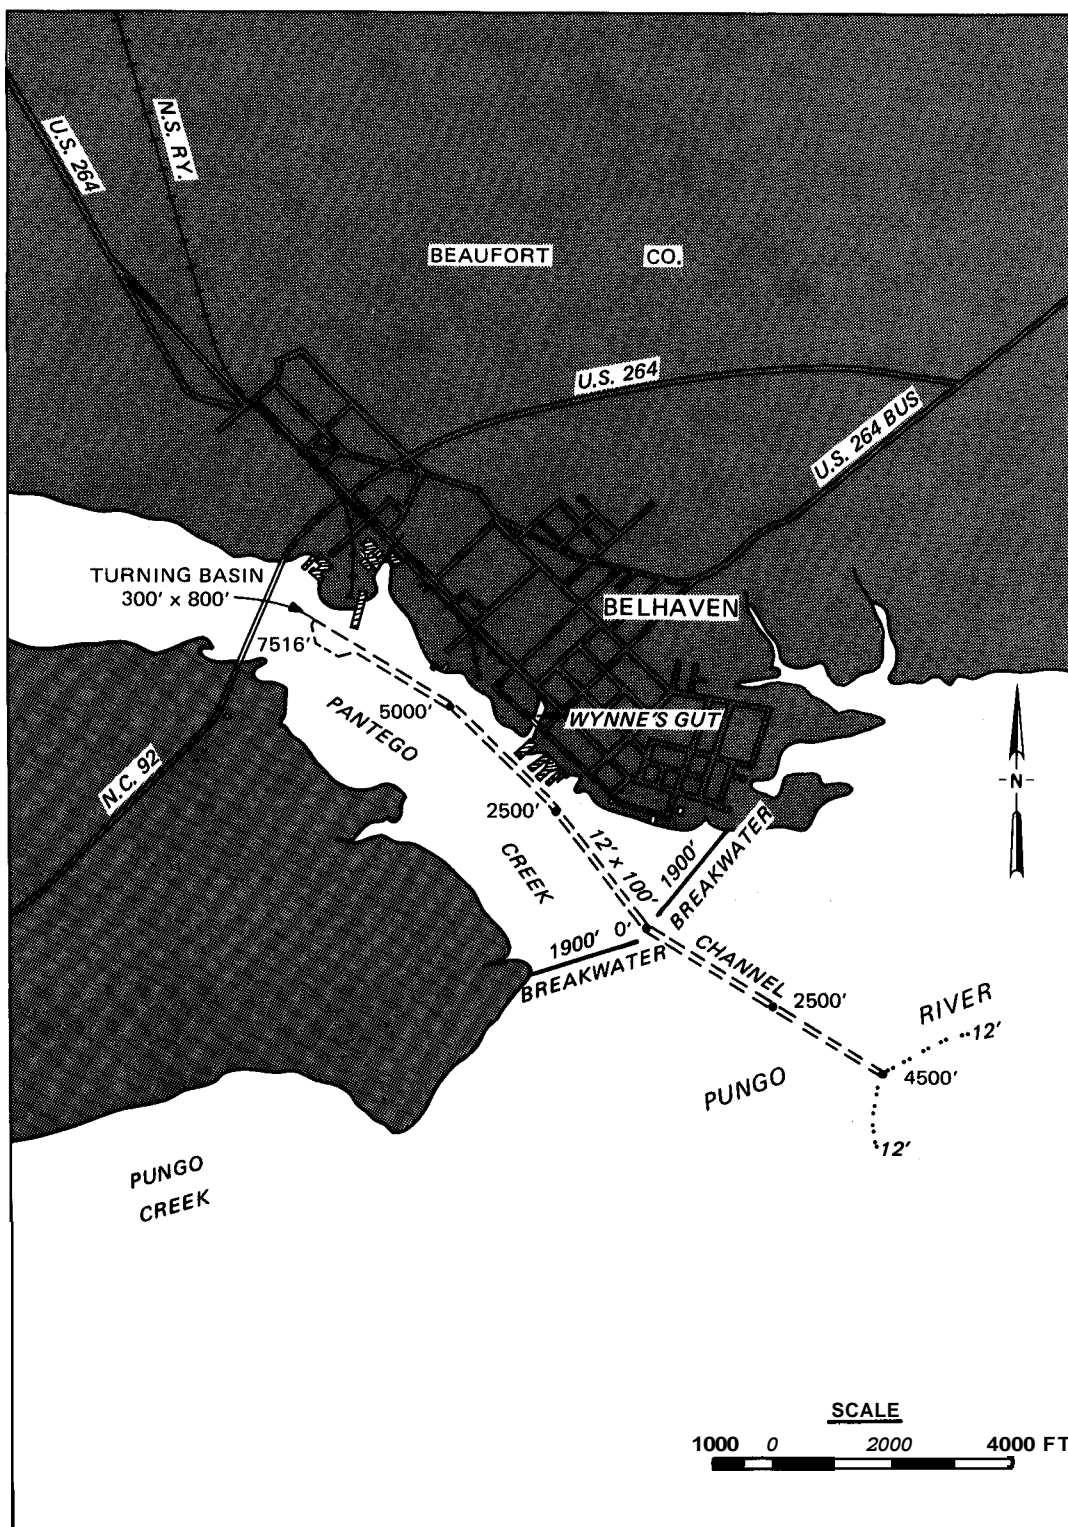
Figure 5. Belhaven Harbor, North Carolina

1982	Visual examination showed that approximately three dozen timbers were missing over the length of the breakwaters. Also, a few pilings were missing. It was thought that the damage resulted from the impact of transient barges tied to the structure.
1985	The structure does not provide its intended wave protection, but at present there are no plans for improvement.

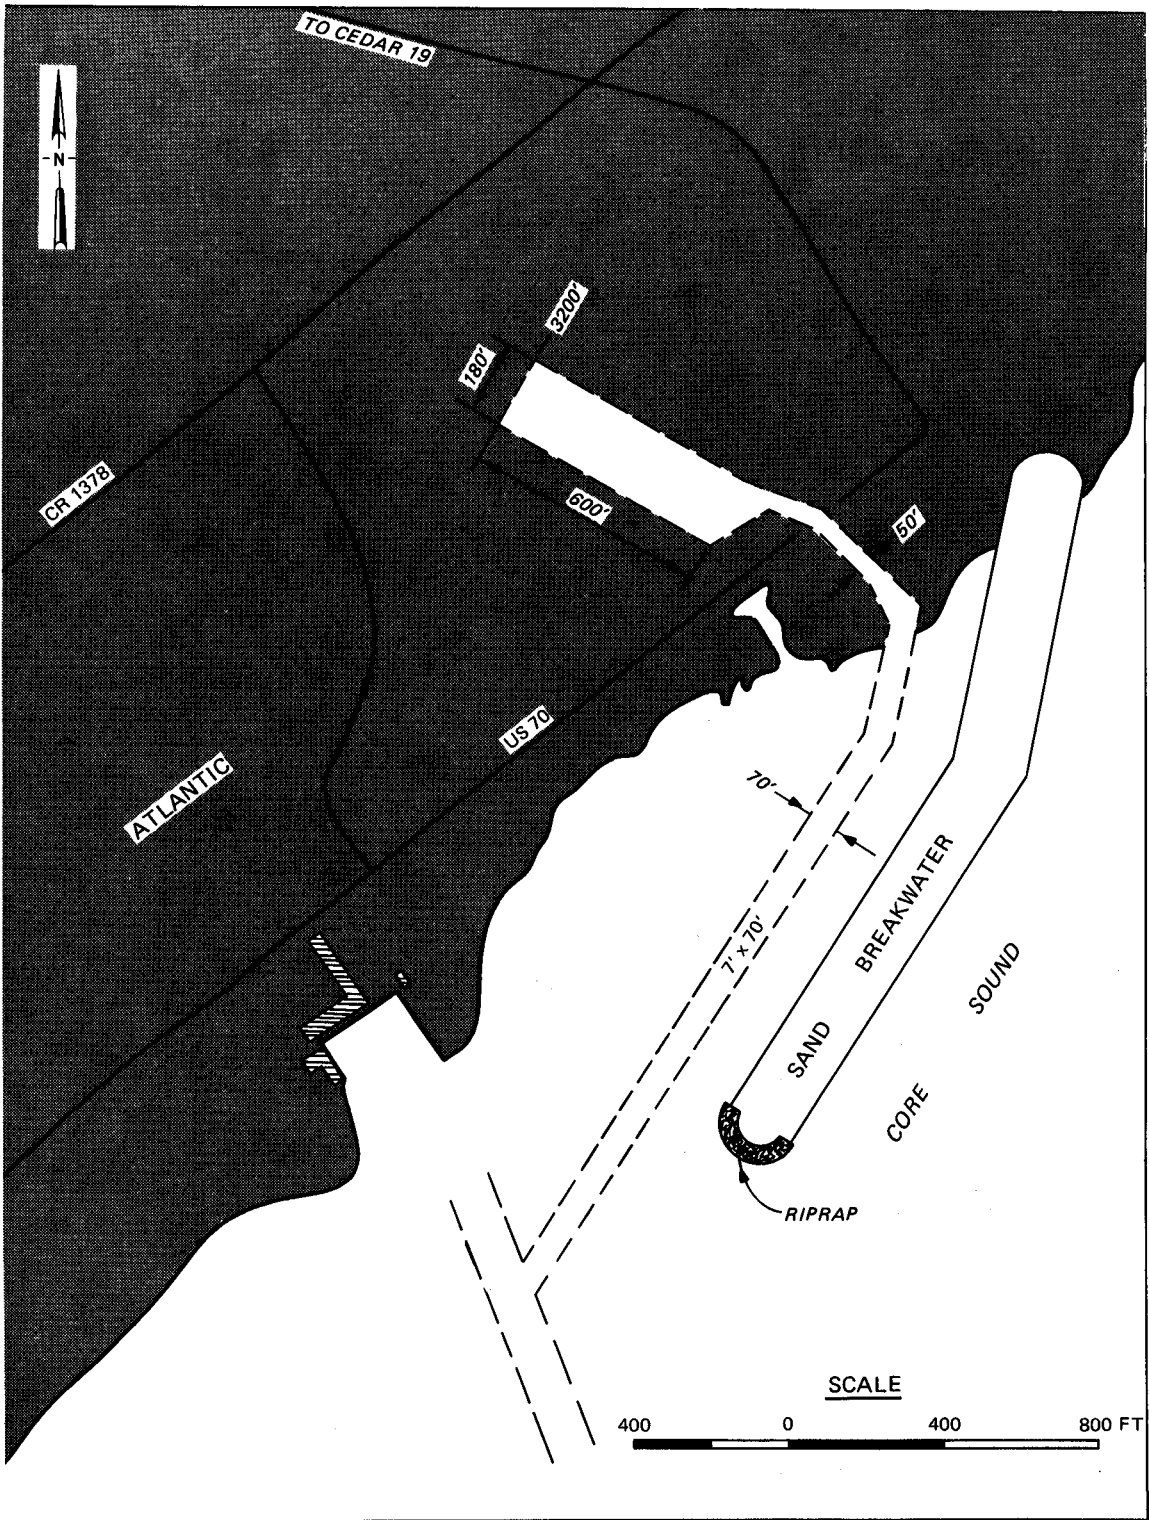
Figure 8. Atlantic Harbor of Refuge, North Carolina

<u>Date(s)</u>	<u>Construction and Rehabilitation History</u>
1971- 1972	A 2,000-ft-long sand breakwater (Figure 8) with a riprap head was constructed in February 1972 as part of the Harbor of Refuge project. Material dredged from the access channel was used for the breakwater. A tentative design section called for a crest width of 15 ft at an elevation of +8 ft mlw, with side slopes of 1V:10H above mlw and 1V:20H below. The head of the breakwater would have a 3-ft-thick riprap section from -1 to +3 ft mlw. This design section was similar to the one used on the Stumpy Point Bay breakwaters. Estimated quantities were 46,500 cu yd of sand, 3,232 tons of stone, and 6.5 acres of grass (to hold the sand in place). The estimated total cost was \$51,400.
1973	Erosion had occurred along a 400-ft section of the southeastern face of the breakwater. The erosion extended from 35 to 60 ft into the embankment, creating an escarpment of about 3 ft, and the planted grass had been destroyed in this area. Also, the stone protection on the south end of the breakwater (previously covered with sand) had become uncovered, displaced, and scattered. The sand fill behind the stone apparently eroded away first, undermining the rock and subsequently displacing it.

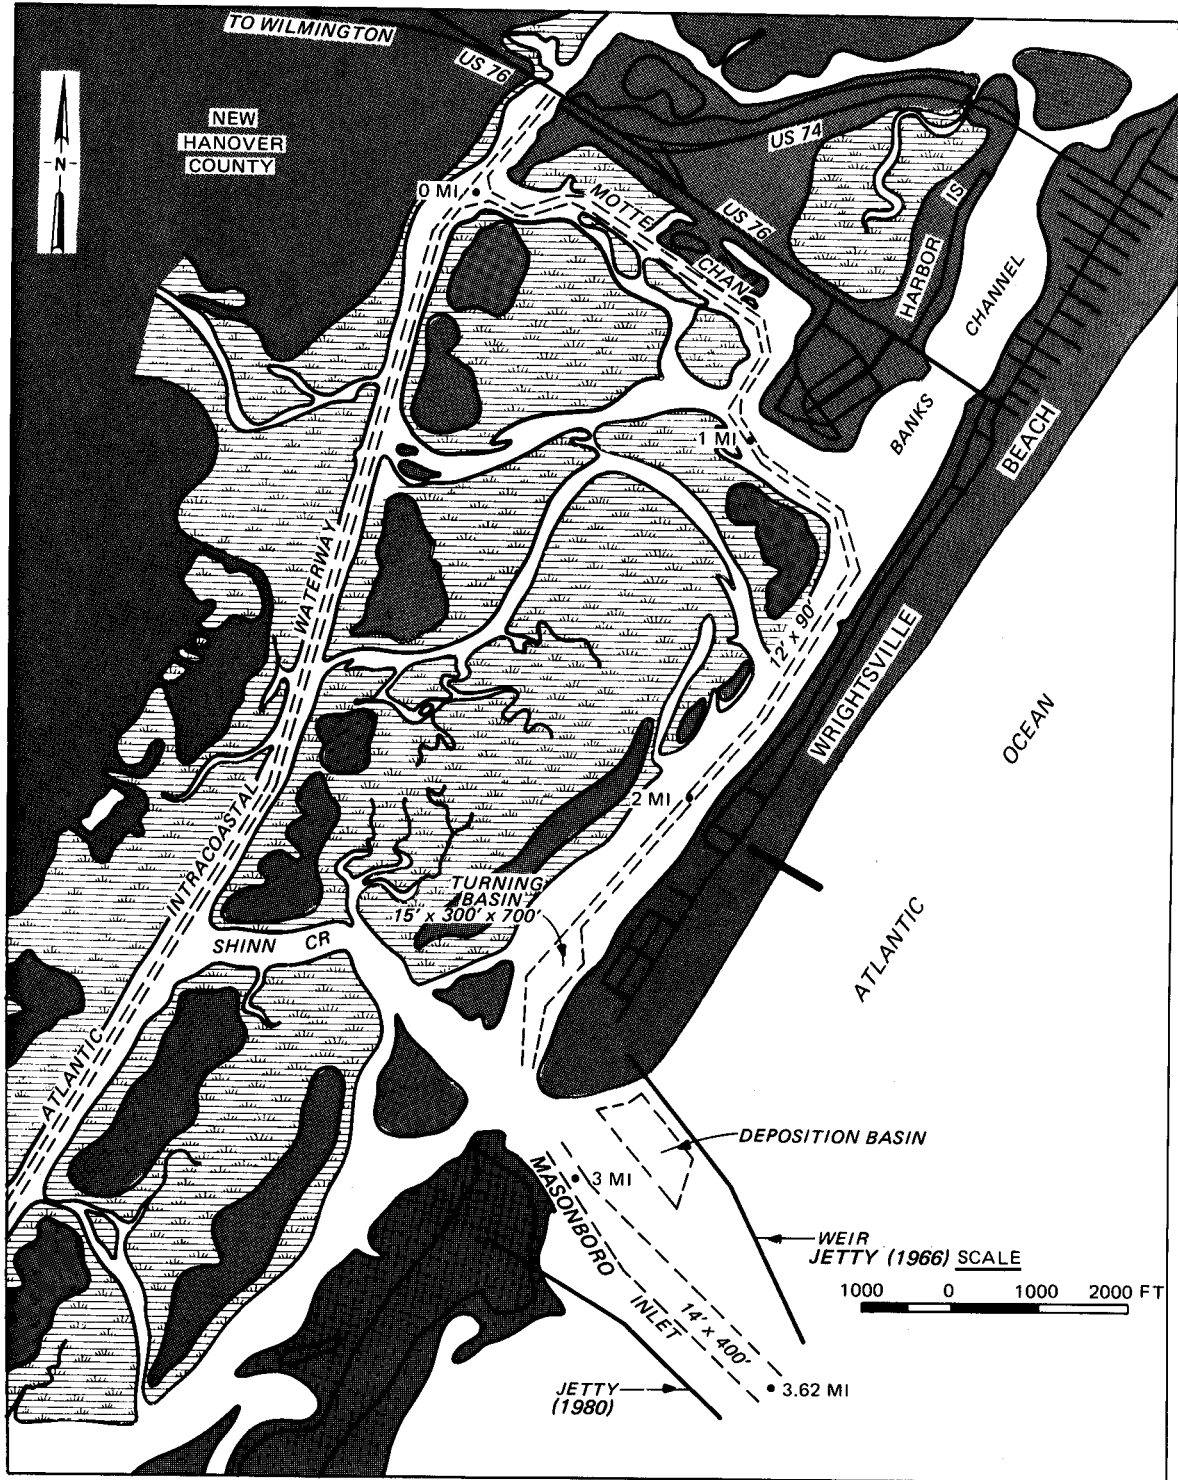
Figure 10. Masonboro Inlet, North Carolina

1985	Presently, the south jetty is in good condition; whereas, the north jetty, which was constructed of smaller size armor stone, is in need of repair work in several areas showing localized armor stone damage.

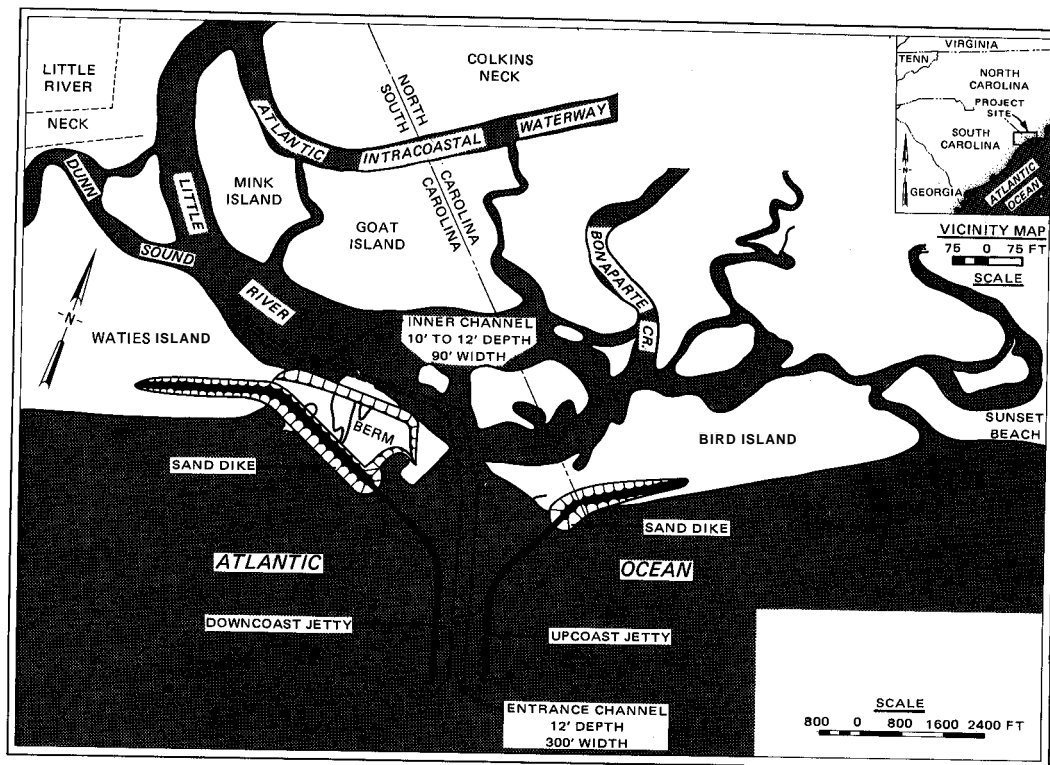
Figure 14. Little River, South Carolina

1986	A visual examination of the structures indicated some displaced stone along the weir section of the north jetty. Surveys also revealed scour holes at the head of the north jetty and along the channel side of the south jetty. No apparent jetty damage was indicated above the water surface. Damage along the toe of the structures, if any, is unknown.

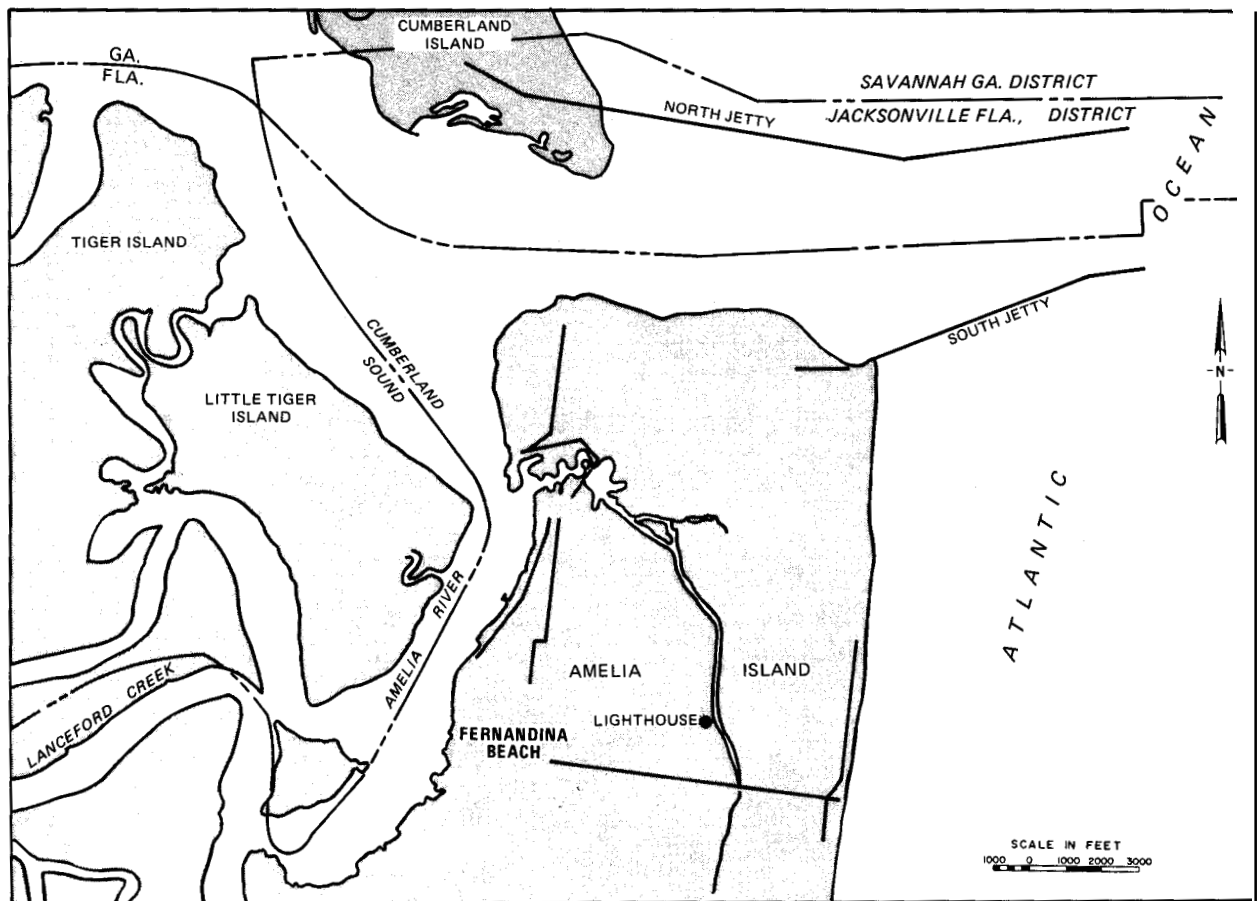
Figure 21. Fernandina Harbor jetties, Florida

Date(s)	Construction and Rehabilitation History
1937	A survey in May showed crest heights of +2.5 to +8.5 ft mlw and +2.0 to +9.0 ft mlw for the north and south jetties, respectively.
1945	A survey of the south jetty in December showed crest heights from +1.5 to +9.0 ft mlw.
1985-1987	At present, a 40-ft-deep by 400-ft-wide channel between the jetties is maintained by the Navy (the Federal project depth is 32 ft). A contract has been awarded to sand-tighten the landward 1,500 ft of the south jetty. (As of 17 Aug 87 the job had not been completed.) Plans call for removal of the existing jetty to -5 ft mlw, placing an impermeable core of precast concrete sections (inverted Y-shape), and rebuilding to a crown elevation of +9 ft mlw using 8-ton (maximum) armor stone.

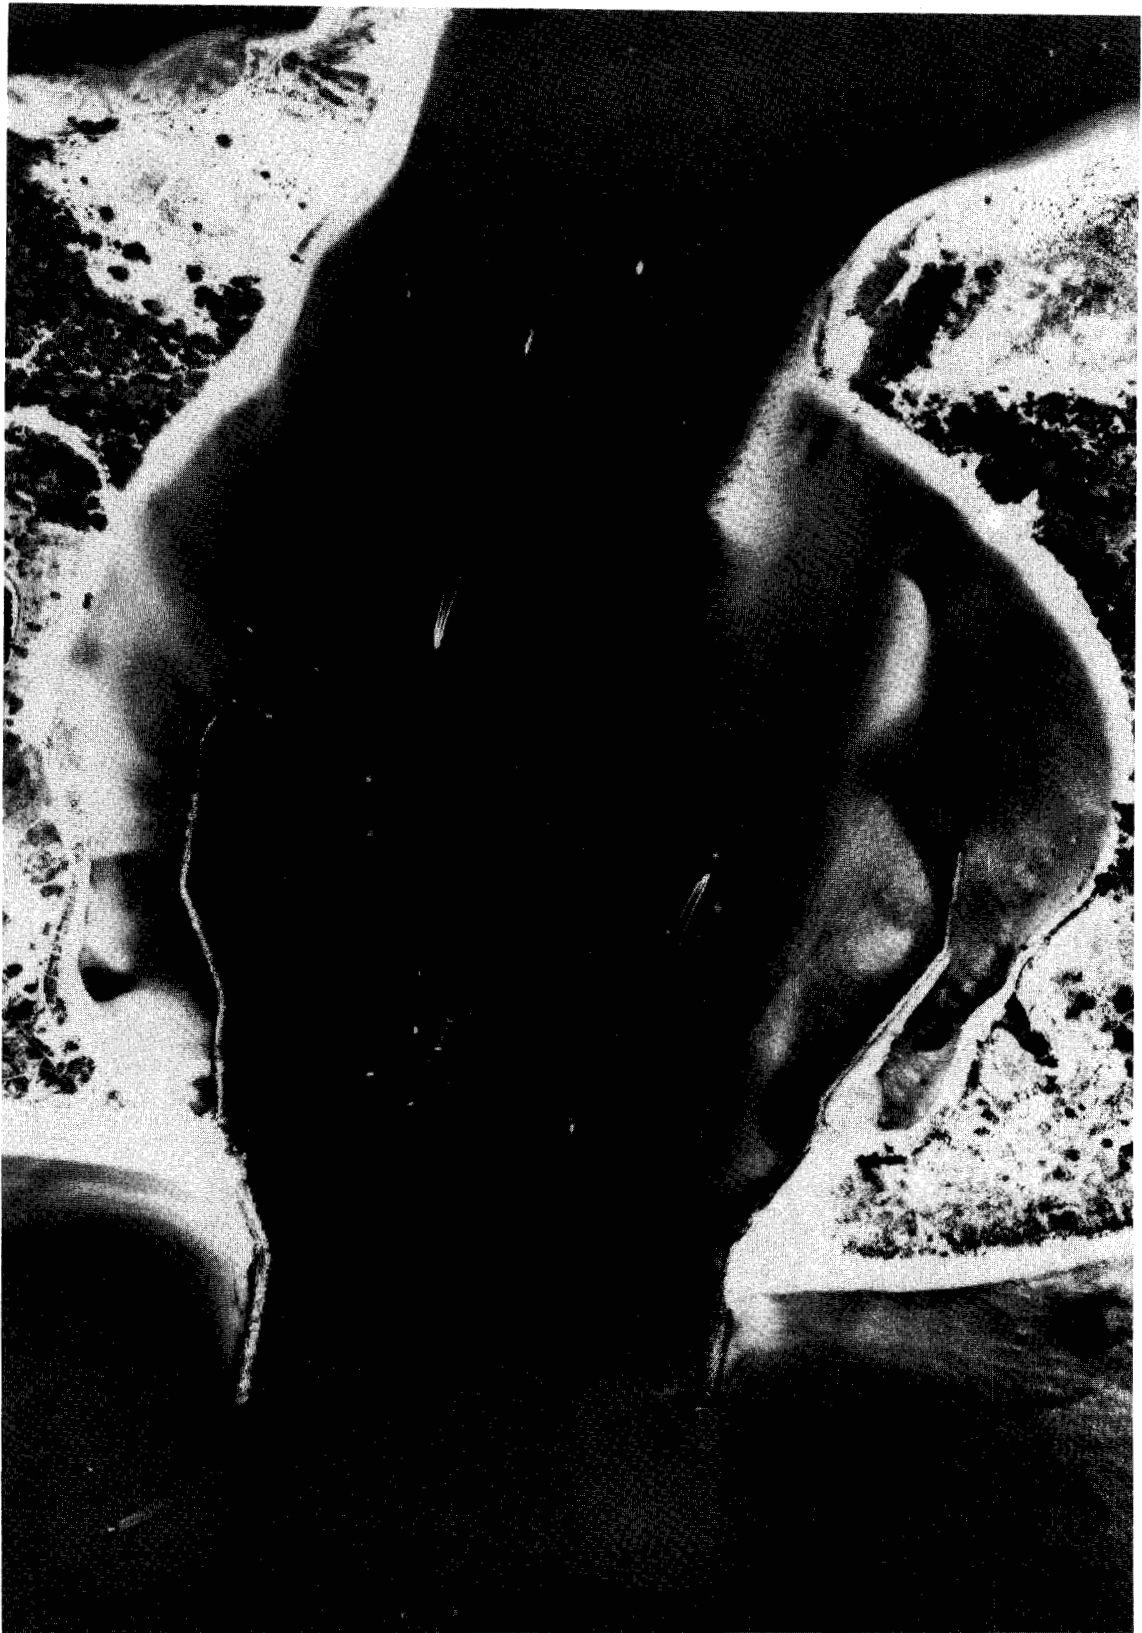
Figure 52. Panama City jetties, February 1984

Date(s)	Construction and Rehabilitation History
1983- 1984 (Cont)	<p>The outer 200 ft of the existing west jetty was in fair condition with an average elevation of +4.5 ft mlw, and the average water depth, seaward of the jetty, was -20 ft mlw. A scour valley extended along the toe of the west jetty head and was approximately 50 ft wide and 10 to 12 ft deep seaward of the jetty axis. The east jetty wing extension was in fair condition with an average elevation of +4.5 ft. The west jetty wing extension was in poor condition with average elevations of +3.5, +0.5, and -7.5 ft mlw along successive landward sections of 700, 450, and 400 ft (landward end). Side slopes were typically 1V:2H or less (i.e., 1V:3H). Rehabilitation of 1,060- and 1,240-ft-long seaward sections of the east and west jetties, respectively, employed 3 design cross sections (Figure 51). The inner trunk section had a +6 ft mlw crown elevation and 5- to 9-ton cover stone. The outer trunk section had a +7.5-ft mlw crown elevation and 9- to 12-ton cover stone. Both sections had 15-ft minimum crown widths. The head section had a +9 ft mlw crown elevation, 20-ft minimum crown width, and 12- to 20-ton cover stone. All sections had 1-V:2-H side slopes except the head semicircles, which were warped from 1V:2H (normal to the jetty axis) to 1V:3H (along the jetty axis). Transition sections (both in geometry and stone size) between the design sections were 100 ft long, except for the east jetty inner to outer trunk transition, which was 79 ft long. The lengths of the head, inner trunk, and outer trunk sections on the east jetty were 100, 301, and 420 ft long, respectively, and on the west jetty were 100, 300, and 500 ft long, respectively. The estimated quantity of cover stone was 21,600 tons. The rehabilitation also required removing approximately 150 ft of collapsed steel sheet-pile wall on the west jetty (beginning 1,000 ft from the seaward end) and breaking up the asphalt layer which covered sections of both jetties (from the 1938 repairs), into segments no larger than 20 sq ft. The entrance channel is presently maintained at a depth of 42 ft and a width of 450 ft. Figure 52 is an aerial view of the jetties taken prior to their rehabilitation.</p>
